Waterfall Corridor Accessibility Audit Results

Transportation and Disability Access Audit with Experts on Historic Columbia River Highway | August 2022

2.1. Latourell Falls/Guy W. Talbot State Park

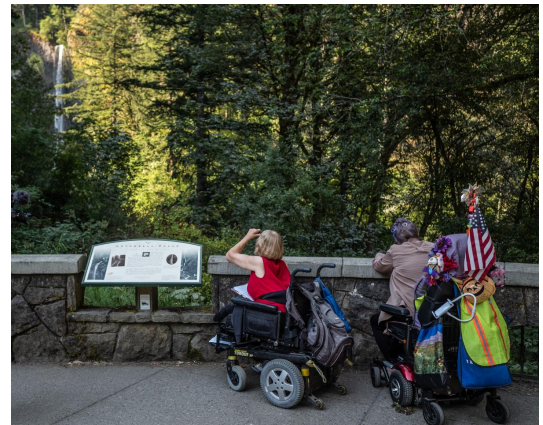
The lookout is easily accessible through the ramp on the curb and offers a view of the waterfall in the distance. The trail towards the waterfall starts after a short flight of stairs with a bench at the bottom. The path has loose gravel on top, but the lookout is paved.

1. Information on the **Latourell Falls** Trailhead should include the fact that the path is loose gravel and can only be reached over a flight of stairs.
<https://stateparks.oregon.gov/index.cfm?do=park.profile&parkId=112>

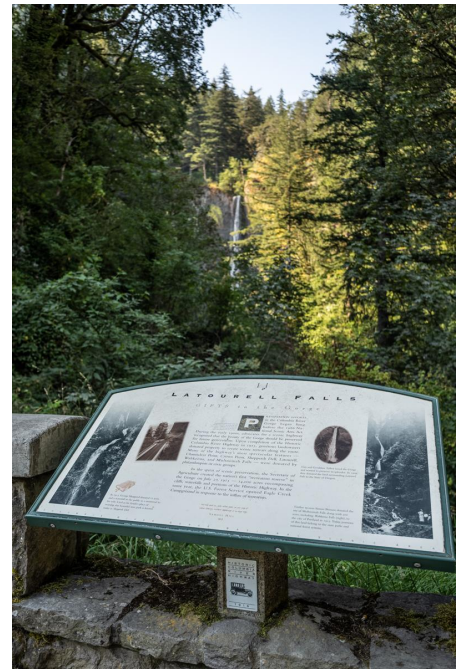
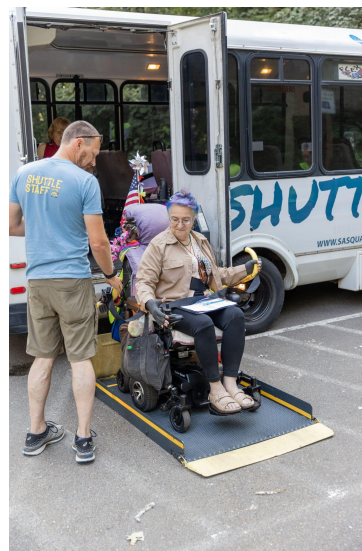
Latourell Falls offers two transit stops, one in the ADA-accessible parking spot and one across the highway. Shuttles stop at the accessible spot when they have riders with disabilities on board. People with less visible disabilities might also want to inform the driver to be dropped off there. The regular shuttle stop forces visitors to cross the highway, which can be unsafe, especially for people with visual or auditory disabilities.

The accessible parking spot offers one ramp onto the curb. The fauna largely covers the view of the waterfall here, but there is direct access to the restroom and picnic benches.

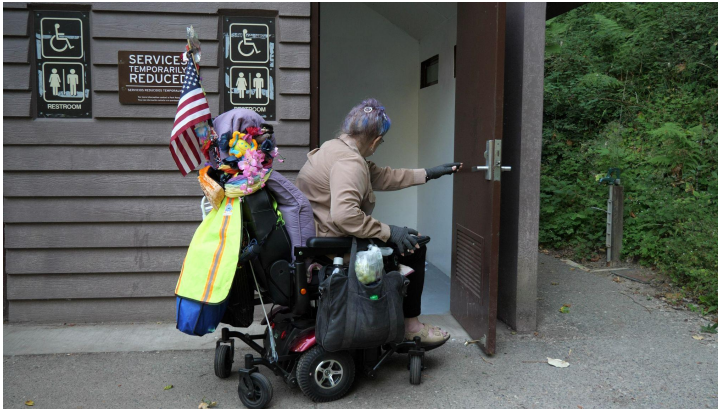
The restrooms feature an ADA-compliant stall. However, the sinks are not accessible for chair users. The building is reachable through a short paved path from the parking lot. The shortcut between the picnic tables and the restroom is not paved and can provide problems for chair users (see the picture on the right below).

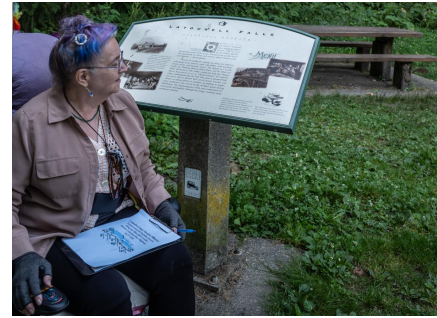
The lookout offers some signs with information on the history of Latourell Falls. None of these are accessible for people with visual impairments. For people unable to walk to the falls, a QR code directing them to a video of the waterfalls would be helpful.

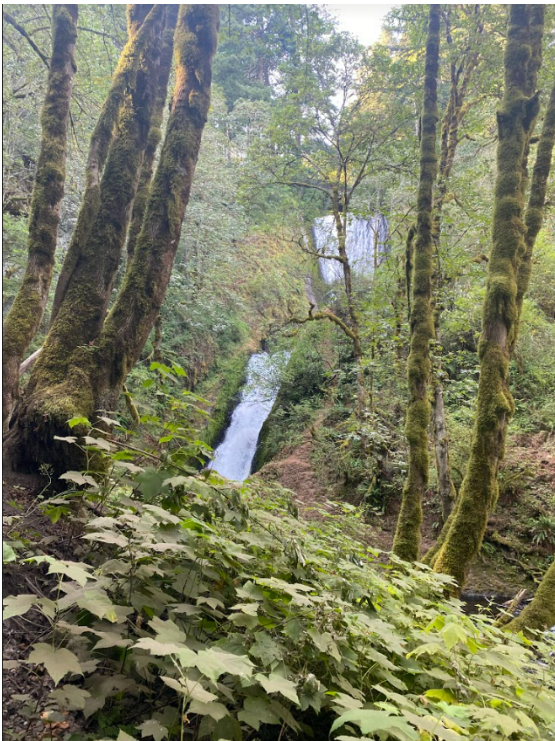
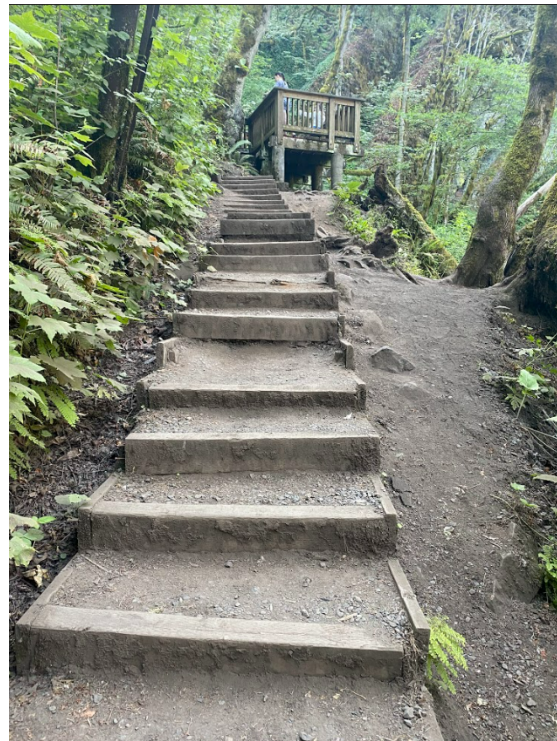
Bridal Veil Falls runs underneath the Historic Columbia River Highway but the lower trail offers the best view of the two-tiered waterfall from a wooden bridge or a lookout platform. The creek is crossed by picturesque wooden bridges and the whimsical forest quickly engulfs any visitor that takes on the steep descent to the bottom of the waterfall. The trail

is only 0.3 miles. It offers one bench to rest on before the main descent. Neither the path nor the lookout platform is accessible for chair users (see pictures below).

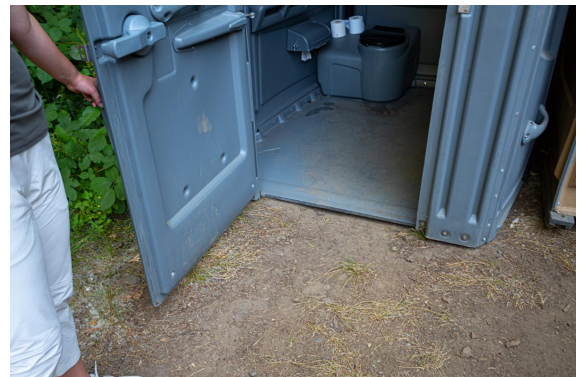
The restroom building was closed at the time of the audit. Instead, several Porta Potties were offered, one of which was marked as accessible. The cabin itself is wider and offers railings, but the Porta Potty is located off the paved path and does not have a ramp leading into the stall.

The designated port-a-potty stall is not usable by people using certain mobility devices such as wheelchairs. While temporary, this should be kept in mind when setting them up in the future.

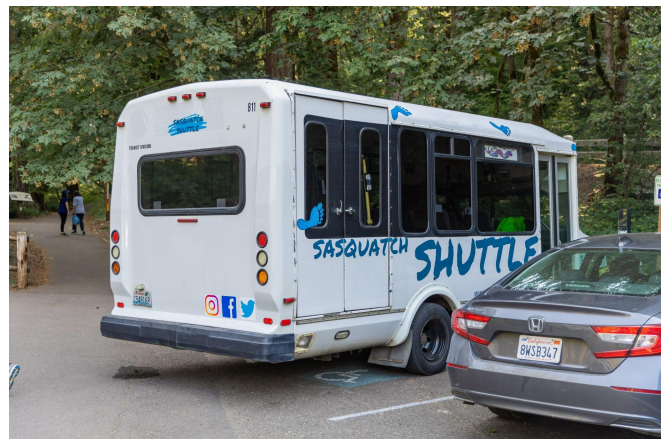
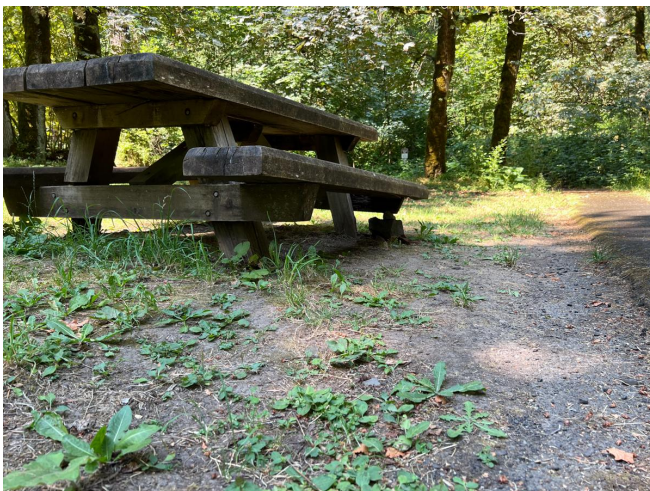
The parking lot is reasonably sized with around 25 parking spaces with one designated accessible vehicle space. The parking space does not have a marked access aisle which can complicate the accessibility of the vehicle. See also the transit stop information below.

The stop for Bridal Veil Falls is located across the highway from Bridal Veil Lodge in the parking lot. The parking spot is missing the correct markings for an accessible parking spot. Consequently, during the audit, the shuttle was blocked in by a car parked in the spot next to it. (An Oregon State Park ranger that we met on the scene told the audit team that the paint for the accessible parking space had run out and was therefore not completed correctly.)

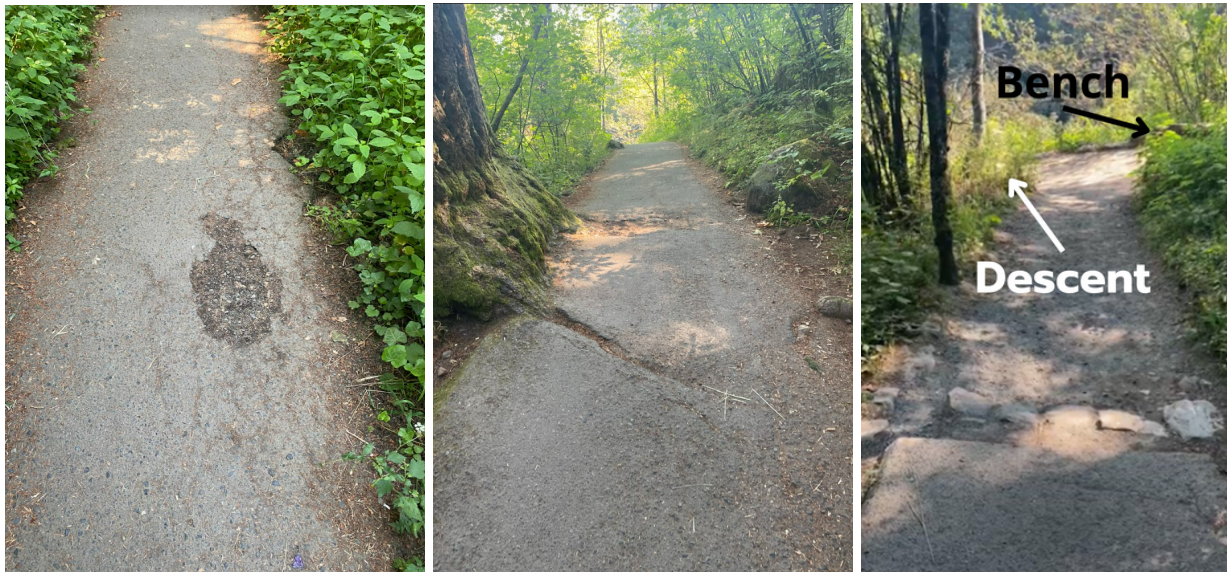
The beginnings of the trails are paved. One of them leads towards the waterfall, but the paving stops abruptly before one can see the waterfall. The 0.3-mile trail that leads towards the waterfall overlook is fairly steep and involves stairs and two wooden bridges.

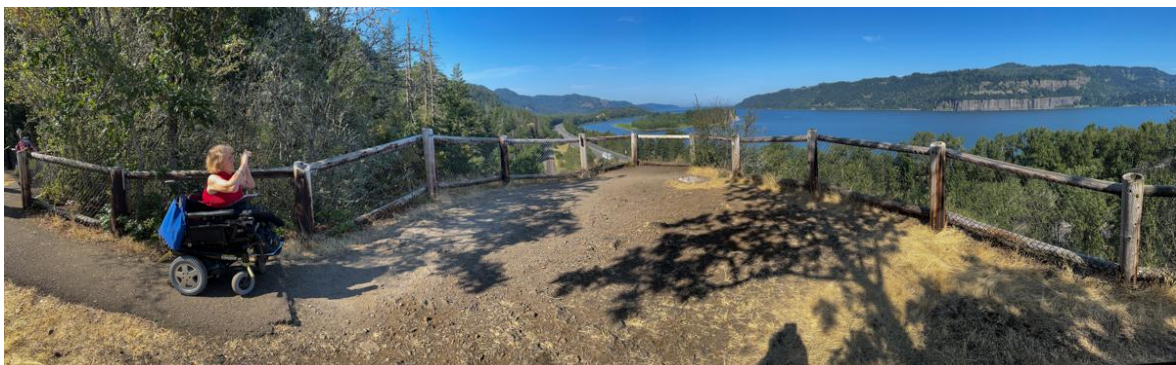
The Overlook Trail is almost fully paved. The pavement stops short of the fenced overlooks. If one can get close to the overlooks, there are impressive views over the Columbia River Gorge. The path has several impediments due to tree roots, and erosion has led to several dips and bumps. It is also narrow enough to cause problems when two chair users try to pass each other.

Above: Incomplete path to Gorge lookout

The sustained damage on the paths should be repaired. Weather conditions in the Gorge make regular maintenance necessary. The picnic area and lookouts along the Overlook Trail could be paved to expand the views for people using mobility devices even further.

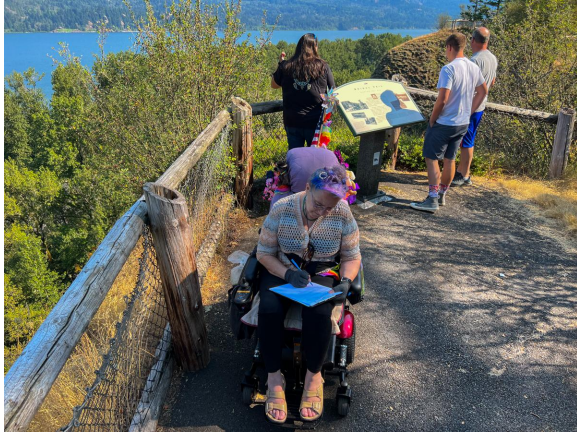
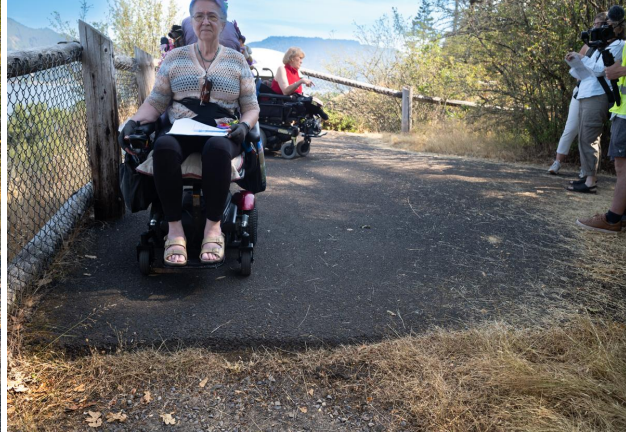
Above: Incomplete path to and from overviews and path interruptions

Right: Erosion obstruction

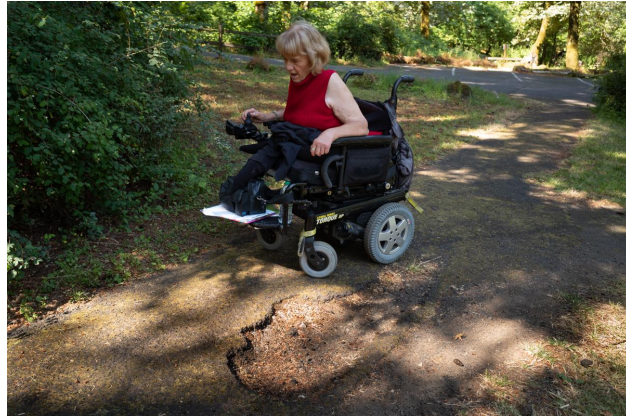
Several signs along the Overlook Trail refer to the local wildlife and history. These could be more accessible with additional QR codes. As previously mentioned, the signage of this parking lot is also incomplete.

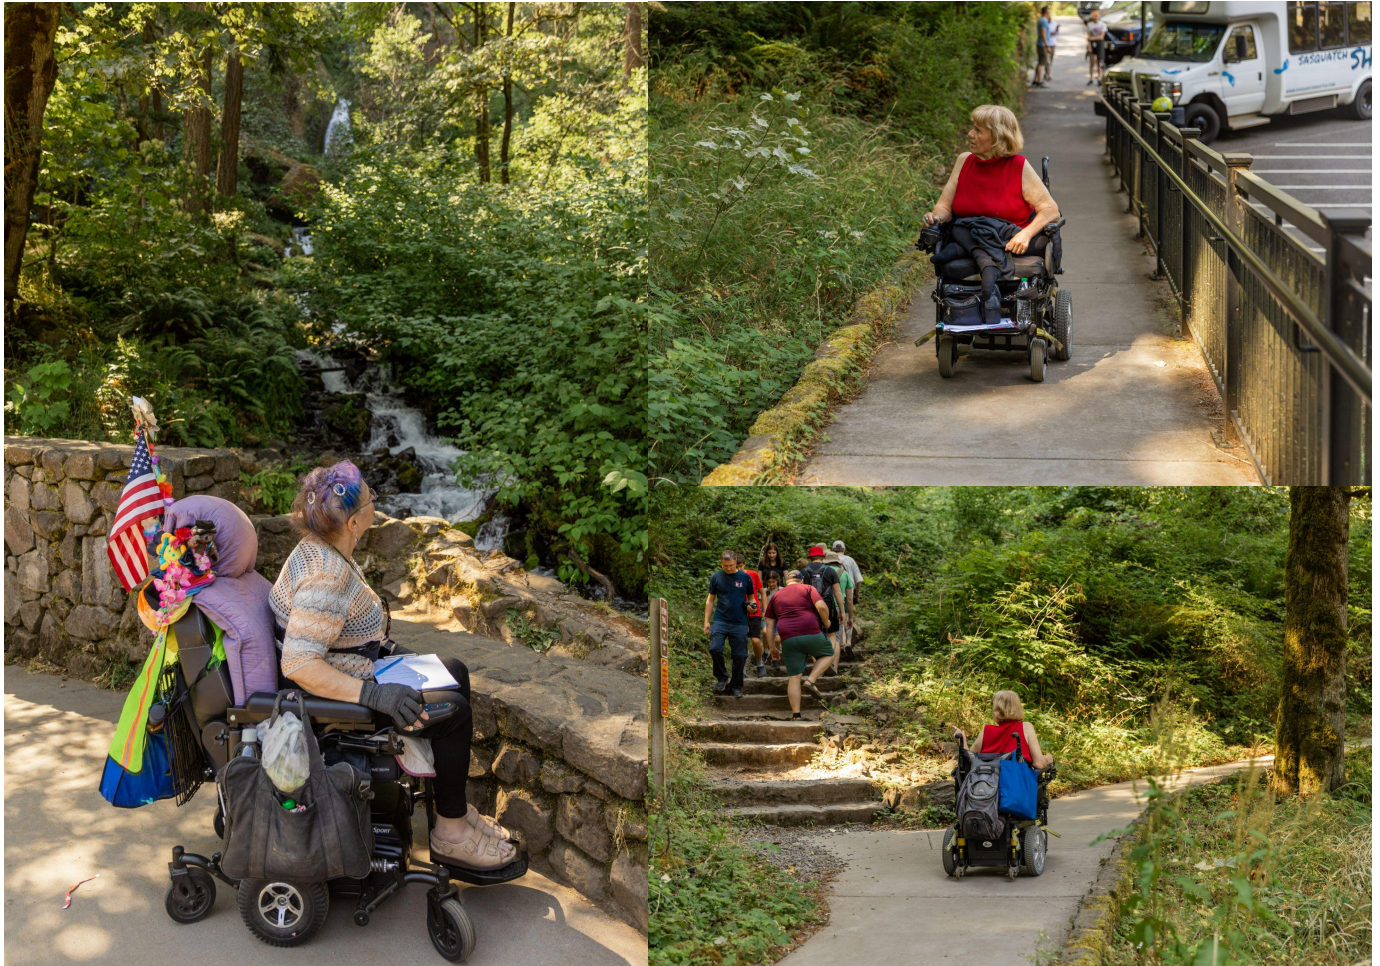
This viewpoint is up close to the waterfall with low walls that can easily be looked over by chair users or can be used for resting. The waterfall is easily visible and spectators can even feel the spray of the water. The trail up to the waterfall starts with a flight of stairs making it inaccessible for people using mobility devices.

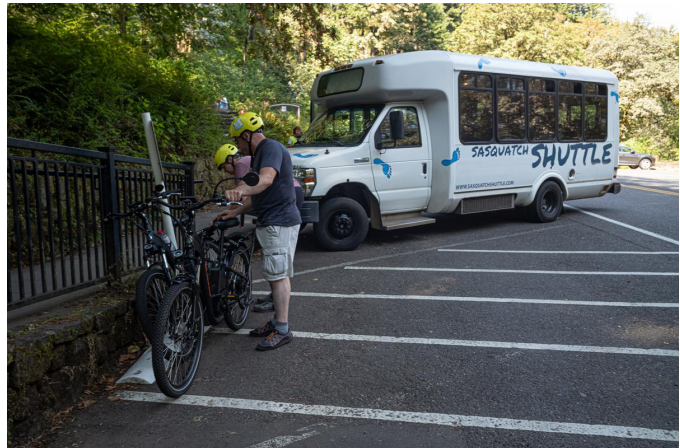
The shuttle stops in the ADA-accessible parking spot when traveling with visitors with disabilities. This is right where the regular shuttle stops as well. They are both close to the ramp leading onto the curb. The depth is shallow for the shuttle used in the audit; its bumper protrudes into the road.

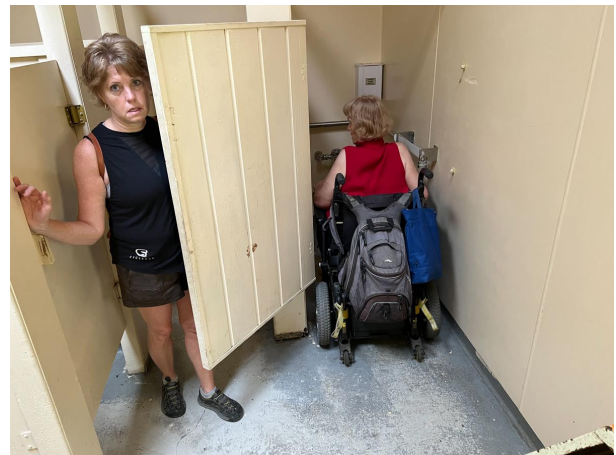
There are restrooms located in the lower parking lot. There is no accessible stall available. The wider stall only allows for a front approach, and the sink area is not accessible for chair users.

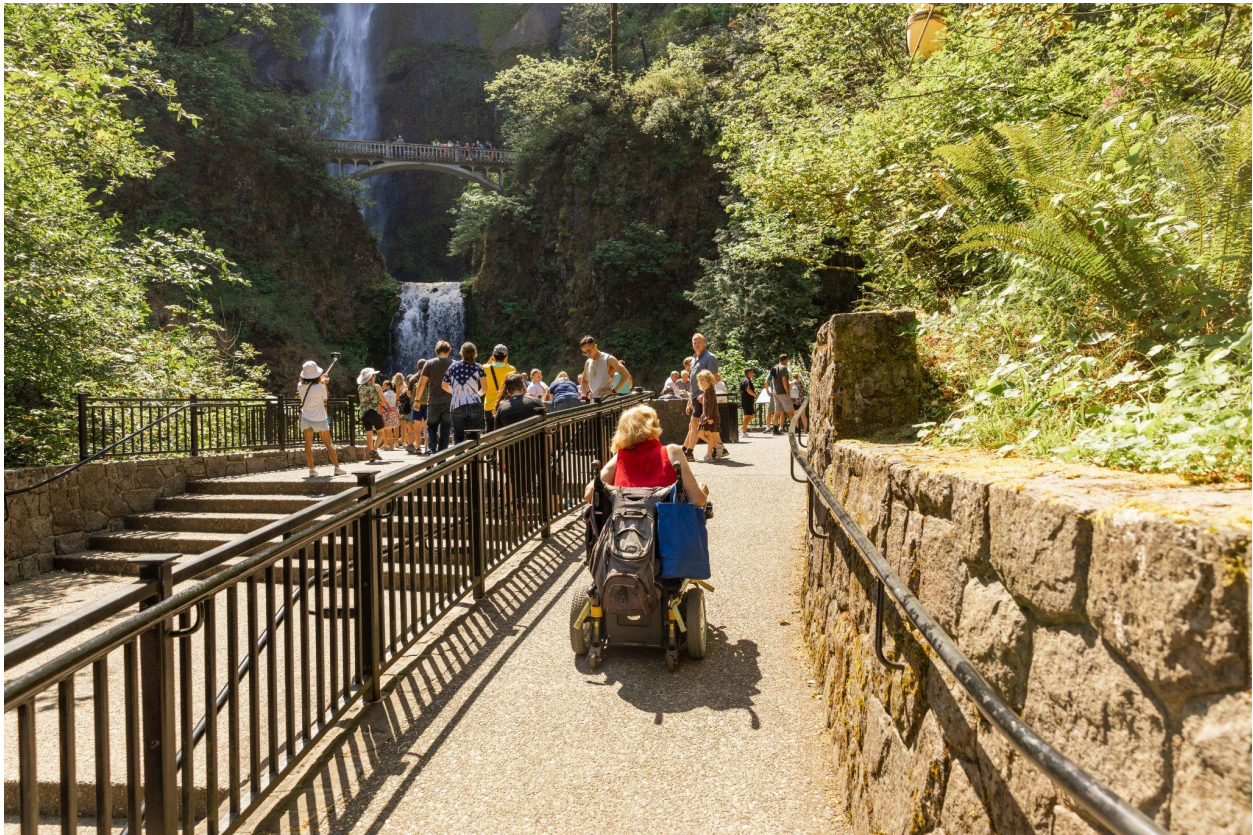
The entire area is often very crowded, which can be stressful to navigate. However, the first viewing area is accessible through a ramp. While it is steep in certain places, it offers enough space to meander up in a motorized chair. The flat part of the ramp is fairly narrow, making it difficult for two chair users to pass each other. The entire path up to the viewpoint offers railings on either side.

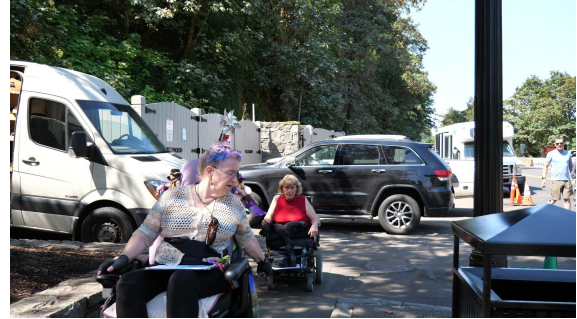
The ADA-accessible parking sits to the right of the Multnomah Falls Lodge. There is only one ramp that leads to the pathway, but it prevents people with disabilities from having to cross the highway.

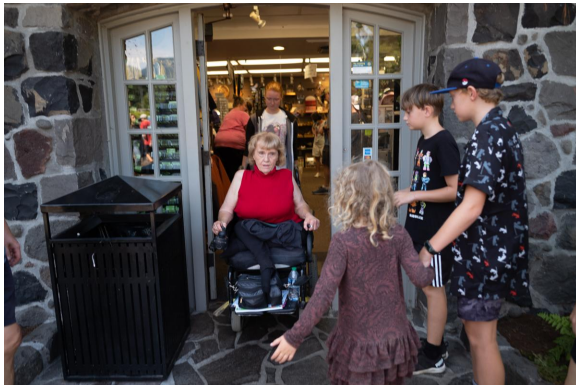
The gift shop is accessible, but the aisles are fairly narrow. Since it tends to be crowded, it can be difficult to navigate for chair users, especially without additional help. The lodge also offers an elevator, which fits one person at a time.

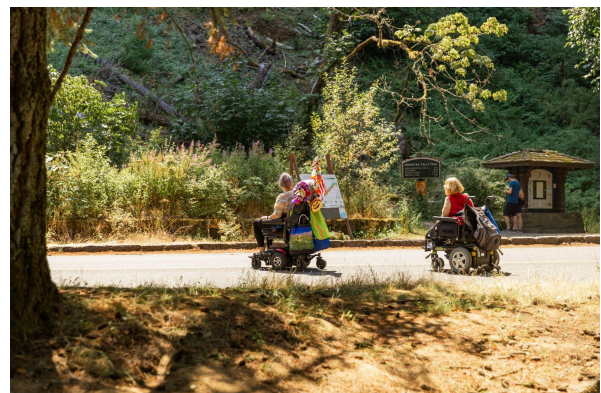
The parking lot is located across the highway from the waterfall. There is no safe crossway for pedestrians. The ADA-accessible parking spots are marked off correctly and offer enough space to load and unload. For access to the waterfall see also information on the transit stop above.

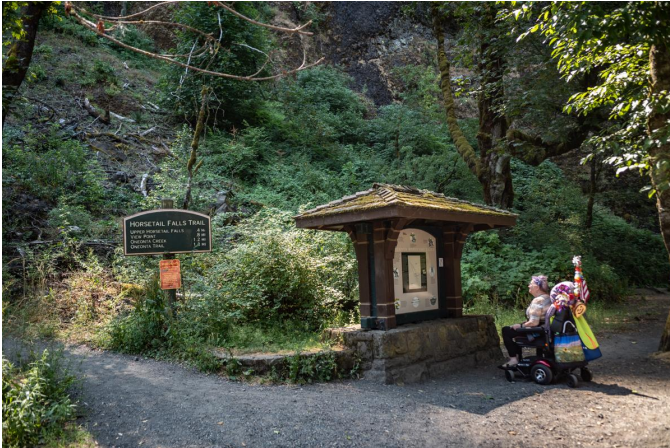
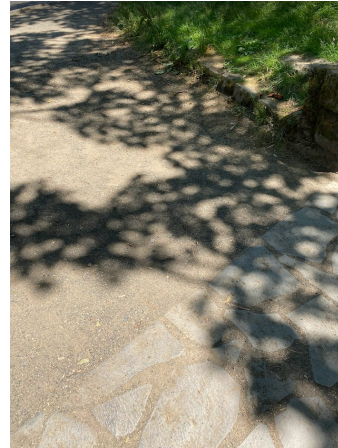
The picnic tables are placed on dirt and the information sign is in an area with loose gravel. People using mobility devices can experience difficulties approaching or backing away from it.

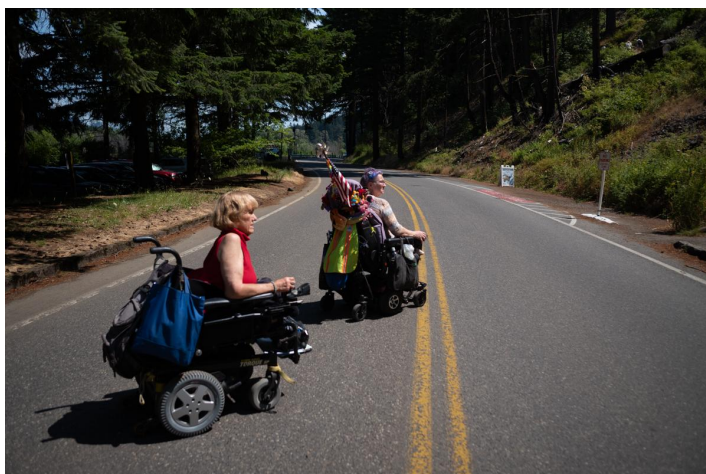
There are no formal cautions for pedestrians on the highway within the waterfall corridor. Blind curves prevent drivers from being aware of slow-walking individuals, strollers, people with white canes, etc. In pre-pandemic times, more than 1,200 pedestrians per hour crossed the

Historic Highway at the Multnomah Falls Lodge during peak times of 10 am to 3 pm. This volume of pedestrians is greater than on any corner in Portland, OR. The maximum there is nearly 850 people per hour around noon.

Some waterfall stops require visitors to cross the HCRH. The missing signage signaling that fact to oncoming drivers poses a great risk, especially for families with small children and people with disabilities. The drivers can be distracted, or sunlight might obstruct their view. This all leads to a great risk for accidents, especially when the ramp on the opposite side of the highway forces people with mobility devices or strollers to cross diagonally.

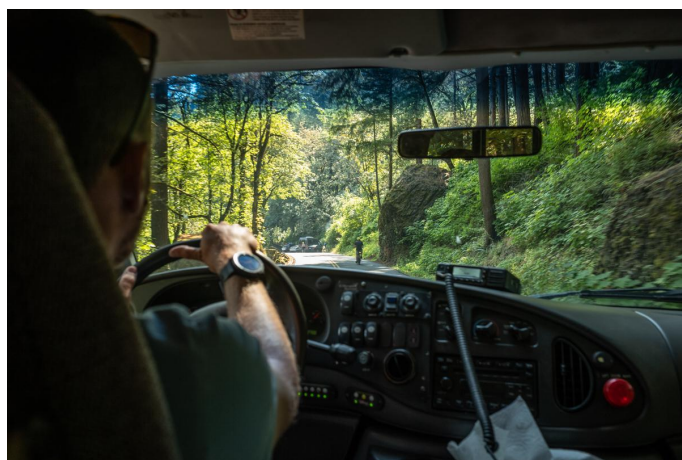
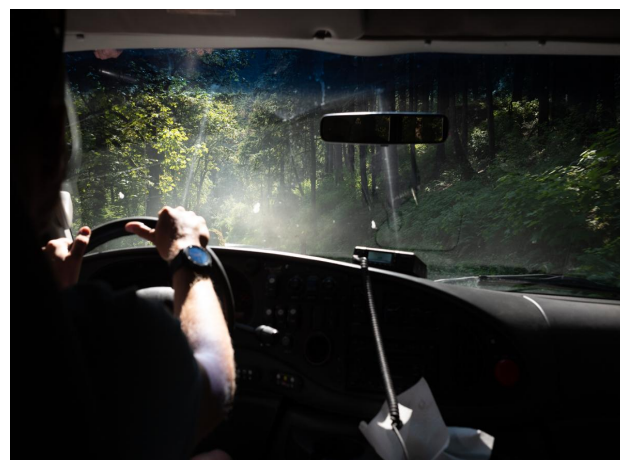
A second condition is the experience of the driver. In the morning, the sun can create a blind spot in the driver's vision when heading eastward, and conversely in the afternoon for vehicles heading westward.

The pictures below illustrate how the sun can obstruct a driver's vision. The first picture features a cyclist that is obscured by a sunbeam in the next one.

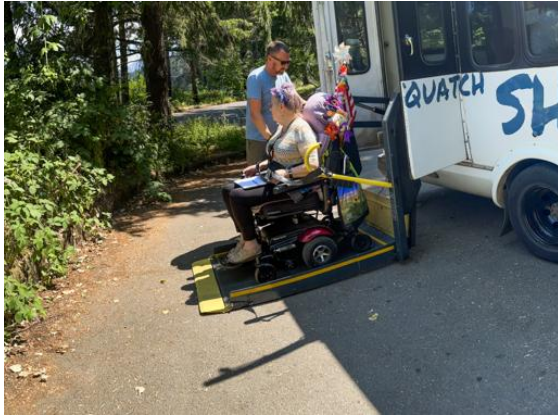
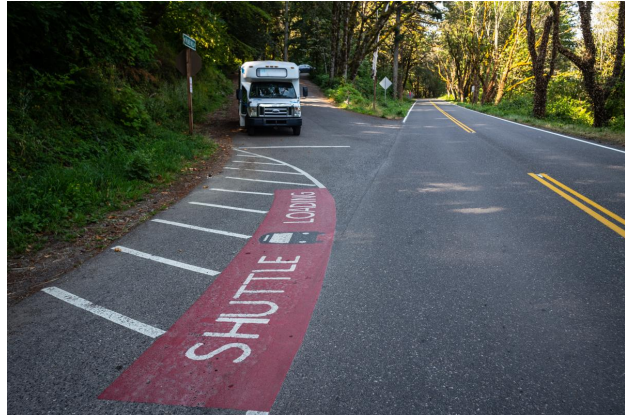
Many of the shuttle stops also do not have room to extend the wheelchair ramp alongside the designated stopping/parking area.
